Chapter 8 Specialized Repairs

8-1. Lock Wall Rehabilitation

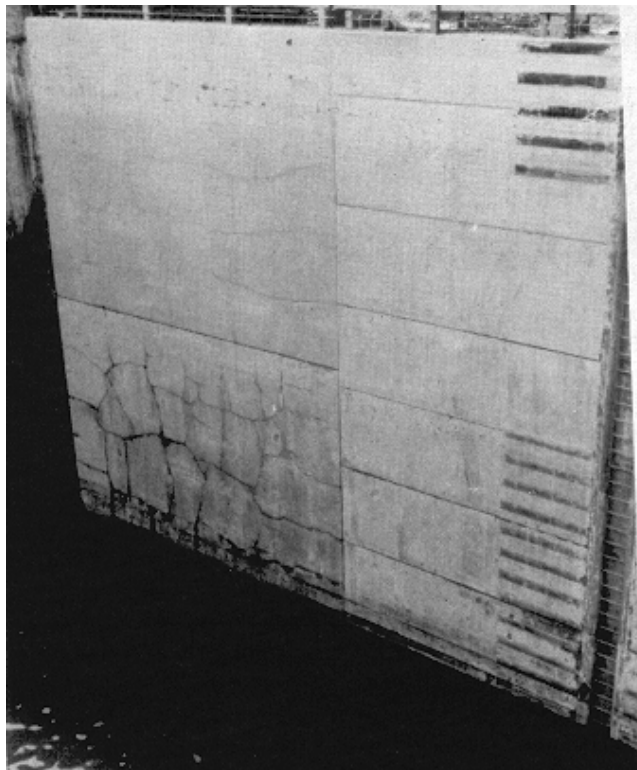
approach is cracking in the replacement concrete. These cracks, which generally extend completely through the conventional replacement concrete, are attributed primarily to the restraint provided through bond of the new concrete to the stable mass of existing concrete. As the relatively thin layer of resurfacing concrete attempts to contract as a result of shrinkage, thermal gradients, and autogenous volume changes, tensile strains develop in the replacement concrete. When these strains exceed the ultimate tensile strain capacity of the replacement concrete, cracks

develop. The lock monolith on the left in Figure 8-3 was resurfaced with a 457-mm (18-in.) overlay of new concrete. As a result of the restraint provided by the existing concrete, extensive cracking developed. The monolith on the right was completely removed and reconstructed in 1.5-m (5-ft) lifts with the same concrete materials and mixture proportions. Without an existing concrete substrate to provide restraint, no cracking occurred.

Figure 8-3. Concrete cracking in resurfaced monolith (left) compared to reconstructed monolith, Lock No. 1, Mississippi River

(b) CEWES-SC recommendations to minimize shrinkage and install a bond breaker (Hammons, Garner, and Smith 1989) were implemented by the U.S. Army Engineer District, Pittsburgh, during the rehabilitation of Dashields Locks, Ohio River. An examination of the project indicated that cracking of concrete placed during 1989 was significantly less than that of concrete placed during the previous construction season prior to implementation of CEWES-SC recommendations. Also, resurfacing of the lock walls at Lock and Dam 20, Mississippi River, resulted in significantly less cracking in the conventional concrete than was previously experienced at other rehabilitation projects within the U.S. Army Engineer District, Rock Island. The reduced cracking was attributed to a combination of factors including lower cement content, larger maximum size coarse aggregate, lower placing and curing temperatures, smaller volumes of placement, and close attention to curing (Wickersham 1987). Preformed horizontal contraction joints 1.5 m (5 ft) on center were effective in controlling horizontal cracking in the rehabilitation of Lock No. 1, Mississippi River (McDonald 1987b).

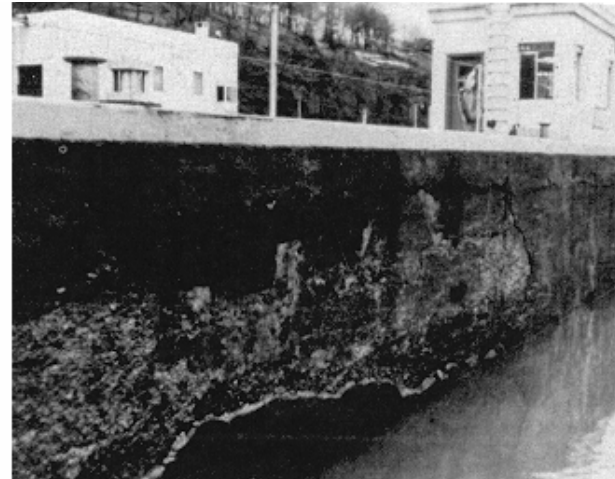
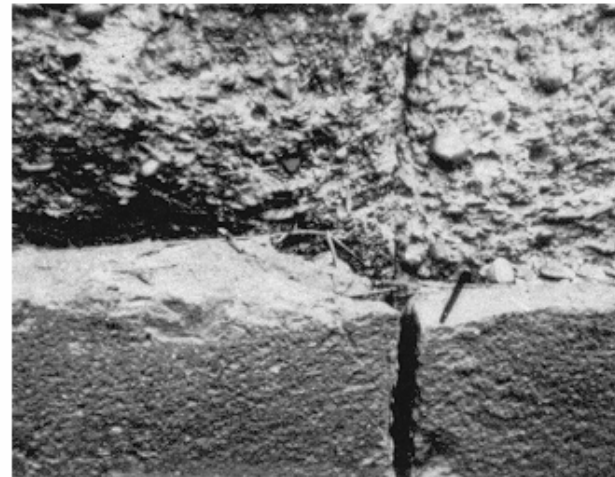
(a) The river chamber at Emsworth Locks and Dam, opened to traffic in 1921, was refaced with shotcrete in 1959. By 1981 the shotcrete repair had deteriorated to the stage shown in Figure 8-5. Spalling appeared to have originated in the upper portion of the wall where the shotcrete overlay was relatively thin and surface preparation minimal. Deterioration apparently propagated down the wall to a point where the shotcrete was of sufficient thickness (approximately 100 mm (4 in.)) to contain dowels and wire mesh. Horizontal cores from the chamber walls showed the remaining shotcrete to be in generally good condition (Figure 8-6a). However, the original concrete immediately behind the shotcrete exhibited significant deterioration, probably caused by freezing and thawing. Cores of similar concrete from the land chamber which did not receive a shotcrete overlay were in generally good condition from the surface inward (Figure 8-6b). This appears to be an example of an overlay contributing to the saturation of the original concrete with increased deterioration resulting from freezing and thawing.

Figure 8-5. Spalling of shotcrete used to reface river chamber wall, Emsworth Locks and Dam

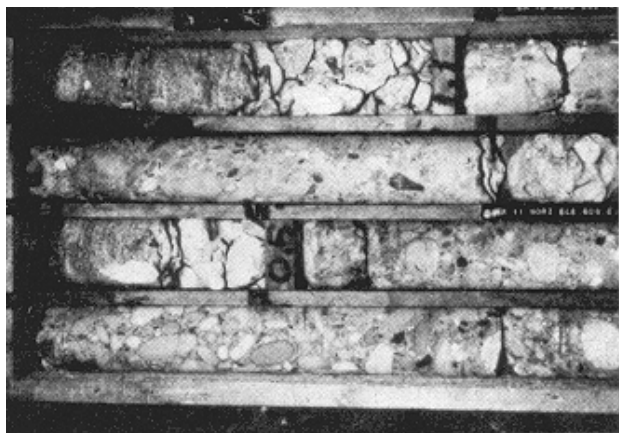
(b) Anchored and reinforced shotcrete was used to reface wall areas of both the Davis and Sabin Locks at Sault Ste. Marie, Michigan. After 30 to 35 years in service, the shotcrete appeared to be in generally good condition. However, cores taken from the lock walls in 1983 showed deterioration of the nonair-entrained concrete immediately behind the shotcrete in several cases (Figure 8-7a). In comparison, concrete in wall areas which were not refaced was in good condition (Figure 8-7b). Laboratory tests of selected cores indicated the permeability of the shotcrete to be approximately one-third that of the concrete. Also, the shotcrete contained

a. Portions of the core from two drill holes through river chamber wall which had been refaced with shotcrete

1.8-percent air voids compared to 0.9 percent in the concrete. In areas where moisture migration did not cause the concrete behind the shotcrete to become critically saturated during cycles of freezing and thawing, the shotcrete was well bonded to the concrete and there was no evidence of deterioration in either material. However, when cores from such areas were subjected to accelerated freeze-thaw testing in a saturated state, the concrete completely disintegrated while the shotcrete remained generally intact (Figure 8-8). Similar cores subjected to accelerated freeze-thaw testing in a dry state remained substantially intact (Figure 8-9).

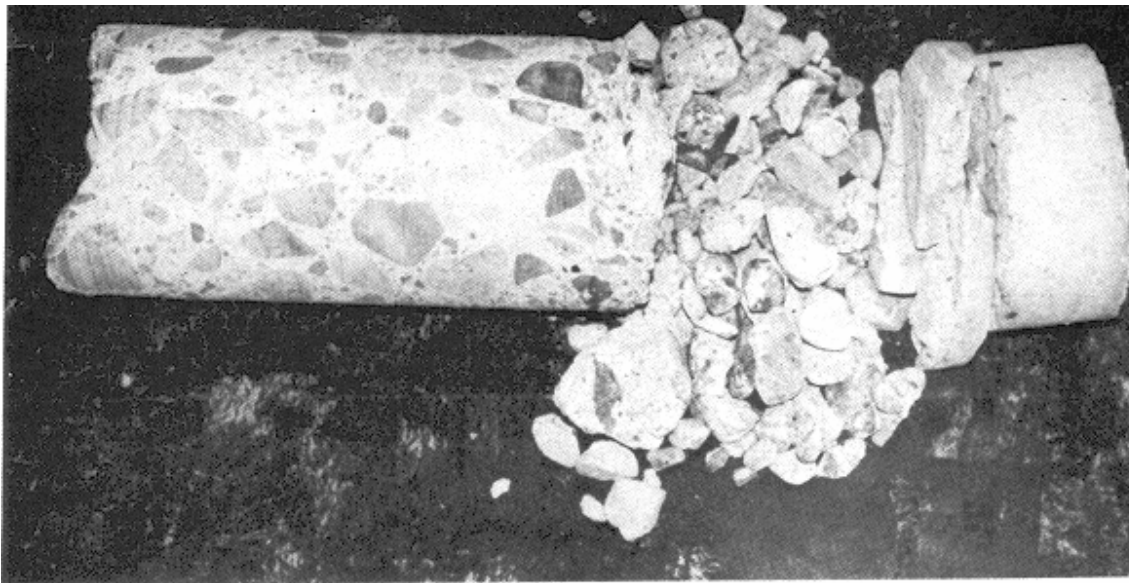
a. Concrete deterioration immediately behind shotcrete overlay

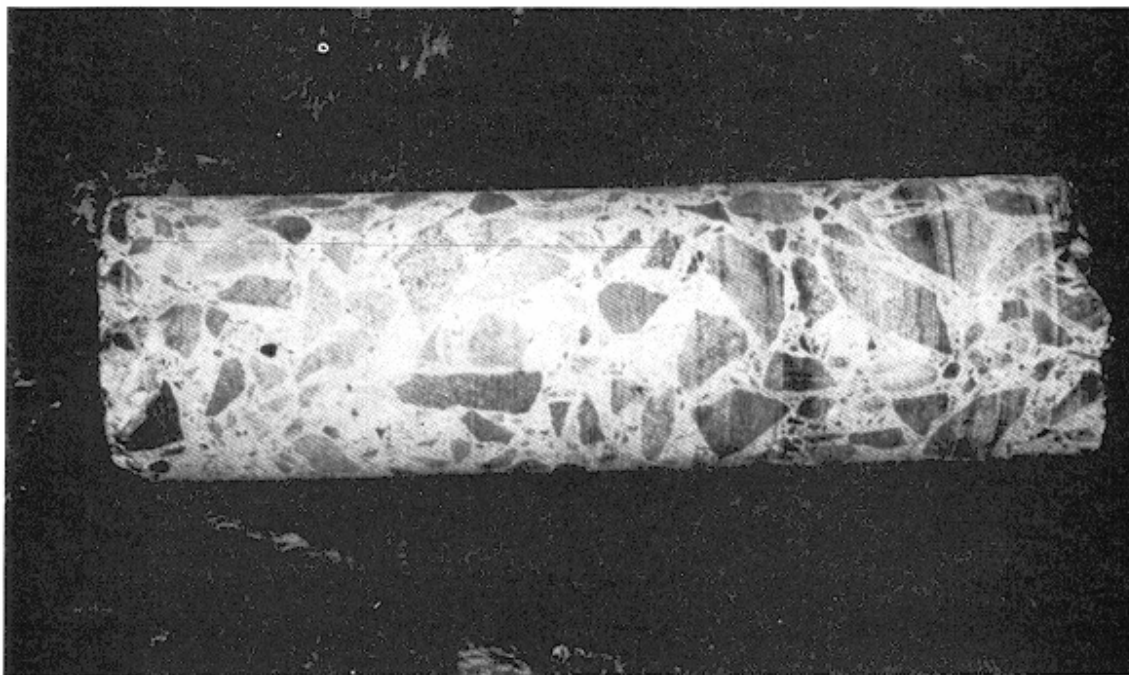
b. Concrete not refaced with shotcrete

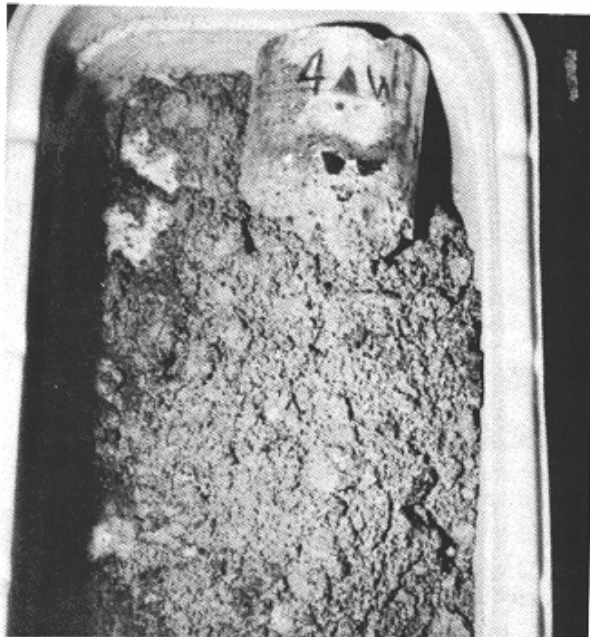
b. After freezing and thawing

Figure 8-8. Combination shotcrete and concrete core before and after 35 cycles of freezing and thawing in a saturated condition

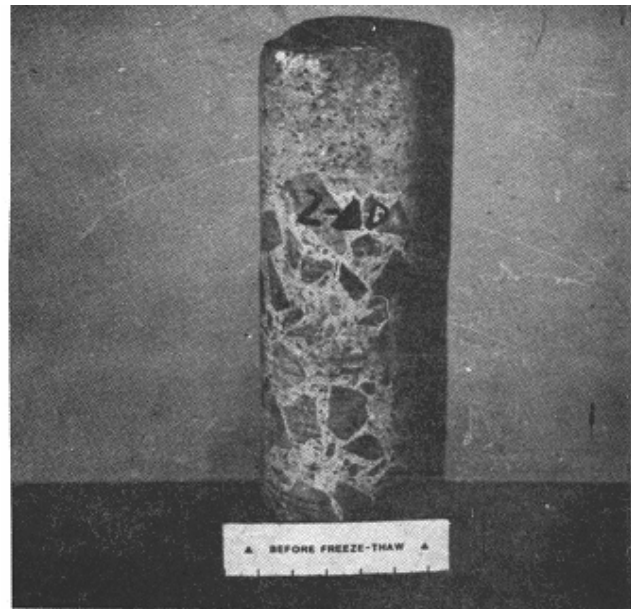
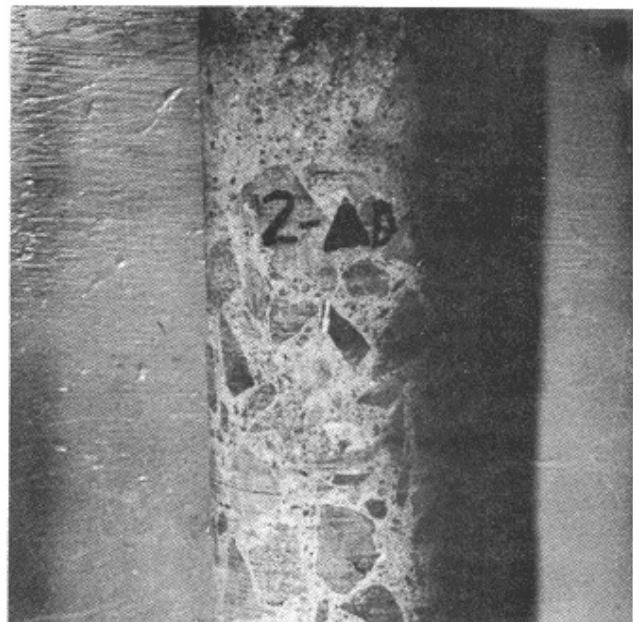
Figure 8-9. Combination shotcrete and concrete core before and after 35 cycles of freezing and thawing in a dry condition

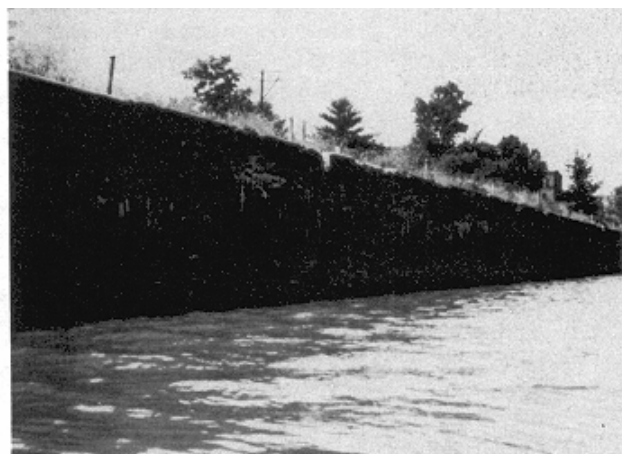
(b) Lock No. 5 was removed from service and, with the exception of the land wall, razed in conjunction with the construction of Maxwell Lock and Dam in 1964. A visual examination of the remaining wall in July 1985 showed that the preplaced-aggregate concrete had some cracking and leaching (Figure 8-11) but overall appeared to be in generally good condition after 35 years exposure. This repair demonstrates that the preplaced-aggregate method of concrete placement is a practical alternative to conventional methods for refacing lock walls.

Figure 8-11. Condition of lock chamber wall 35 years after refacing with preplaced-aggregate concrete

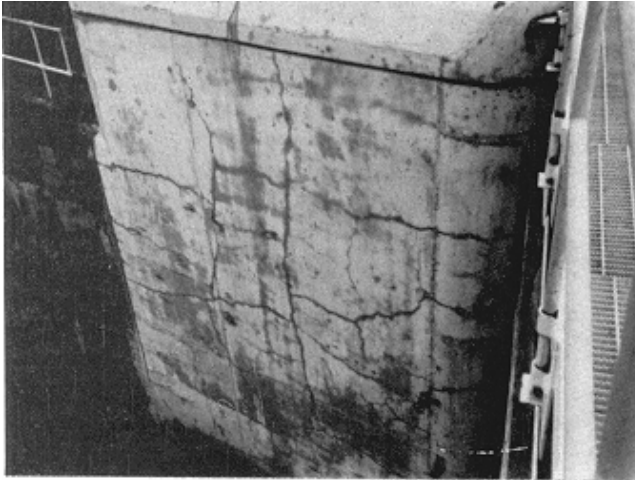
(i) The top of the precast panels was capped with 0.6 m (2 ft) of reinforced concrete, cast-in-place. A 152-mm (6-in.)-thick apron slab was also placed on top of the existing monolith wall to reduce water penetration and improve durability. Joints between panels and concrete cap and between cap and apron slab were sealed with joint sealant. Upon completion of the lock chamber resurfacing, an inspection of the precast panels revealed that 11 of 112 panels exhibited some fine cracks. Those cracks (four locations) with widths in excess of 0.15 mm (0.006 in.) were repaired by epoxy injection. In contrast, the miter gate monoliths previously resurfaced with cast-in-place concrete exhibited extensive cracking (Figure 8-16).

Figure 8-16. Typical cracking in miter gate monoliths resurfaced with cast-in-place concrete, Troy Lock, Hudson River (Miles 1993)

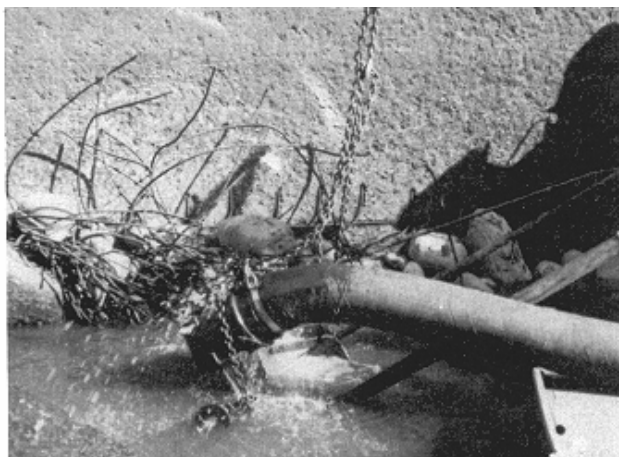
a. Debris collected behind wall baffle

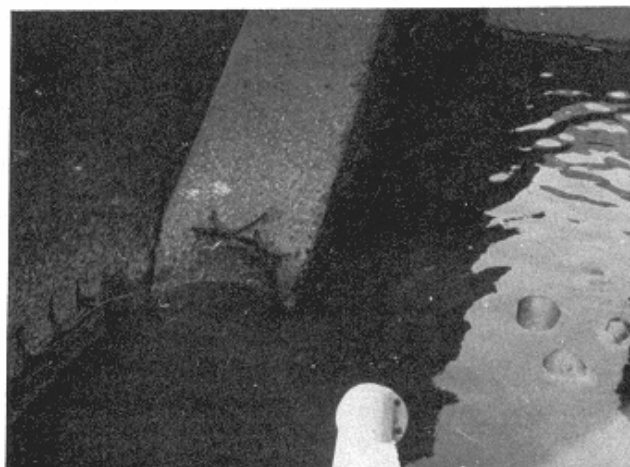
b. Erosion behind wall baffle

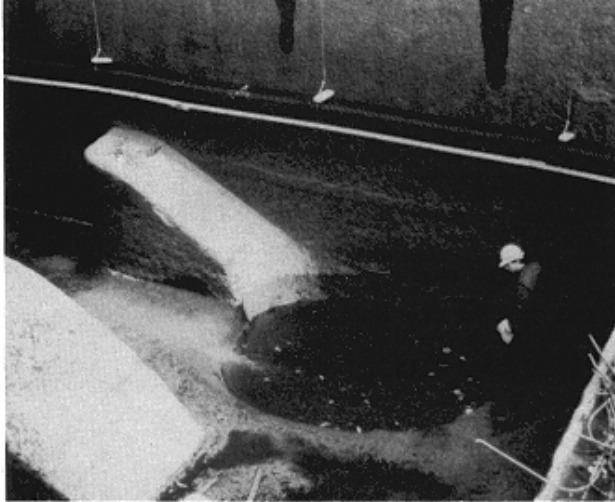
a. Scour holes behind baffles

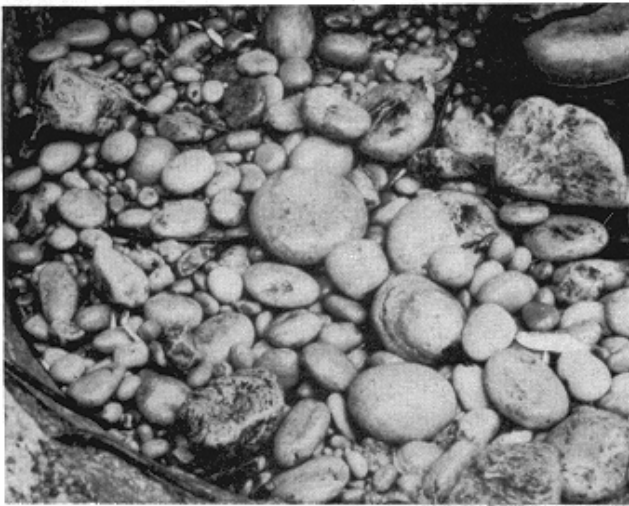
b. Debris in scour holes

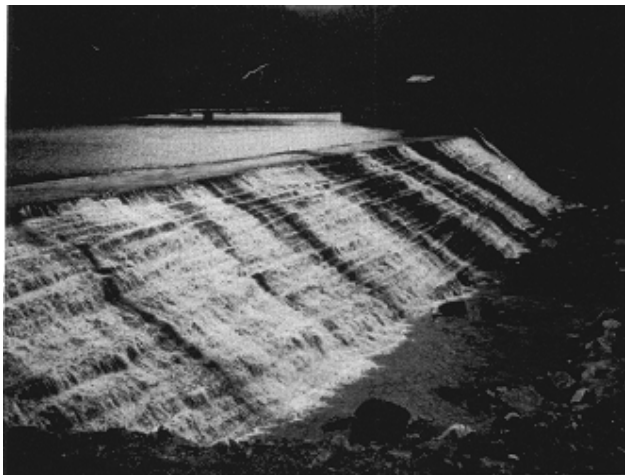
Figure 8-64. Condition of RCC following periodic overtopping, Ocoee No.2 Dam
